Manhole Inspection Summary

Manhole # S03UU1002MH

Insp Date: **8/1/06 2:00 PM**

Location Address: **5900 Park Heights Ave**

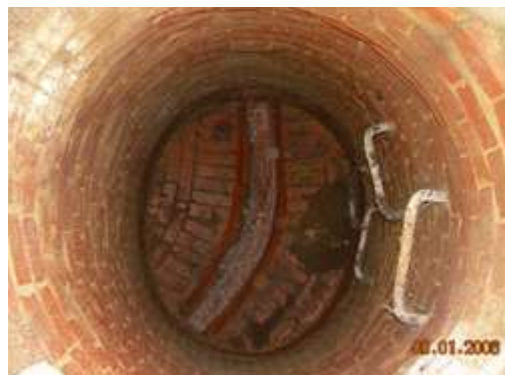
Top View

Adjustment and Barrel infiltration. Bench debris.

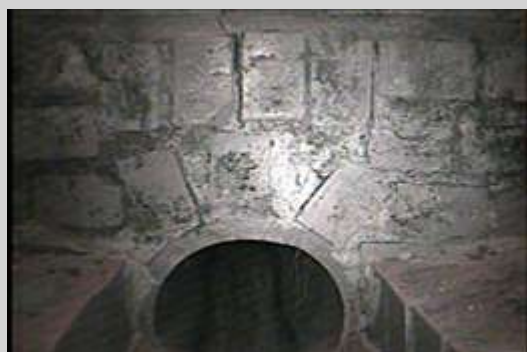
Pipe Out @ 12 O'Clock

Invert Depth: **10.65** (ft.) Flow Characteristics: **Fast**

Infiltration: **None** Pipe Seal Cond: **Unknown**

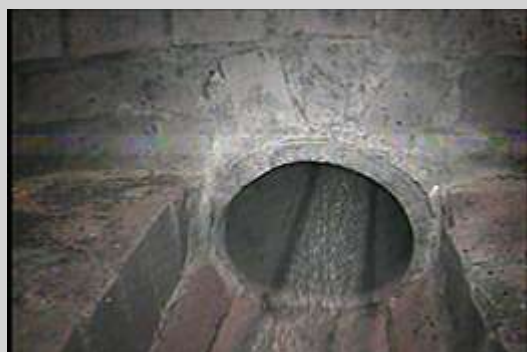
Pipe In @ 7 O'Clock

Invert Depth: **10.28** (ft.) Flow Characteristics: **Fast**

Infiltration: **Evidence** Pipe Seal Cond: **Unknown**
